Technical Service Information

TSI-03-01-01R

Subject: Frame Reinforcements

This TSI applies to S-Series Medium/Bus Models and QSP Medium/Bus Models.

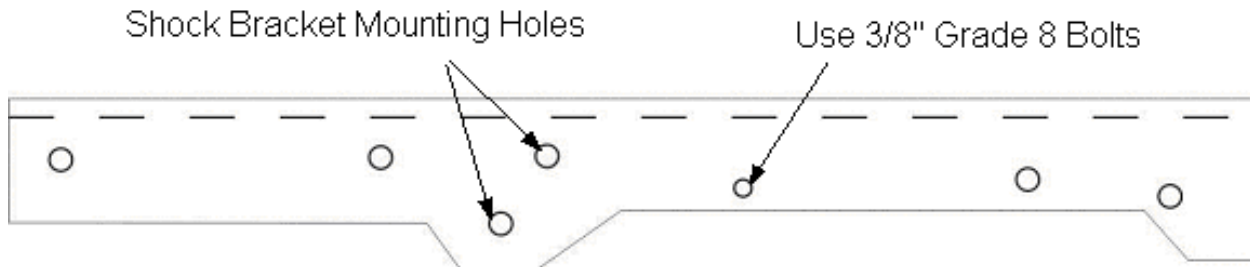
Figure 1 Local Reinforcement — Shock Area

For repairing vehicle frames that have a crack in the engine compartment (shock mounting bracket area) or at the body mount there are now two different style frame reinforcements available. For repairing vehicles with cracks in the frame rail in the Engine Compartment (Figure 1), you should use the below listed Local Reinforcements. For repairing vehicles that have a crack at the body mount area (Figure 2) you should use the below listed Frame Reinforcements.

It is not mandatory for either of the frame reinforcements to be installed. They should only be installed if there are cracks by the front shock mount or in the case of the bus cowl, the cowl mount or at the front body outrigger. It is important to stop drill and weld the crack prior to installing the frame reinforcement. To properly weld the frame refer to the procedure in S01001v Service Manual.

Use 1/2 inch flange head grade 8 bolts in all holes except where otherwise indicated. Tighten 1/2 inch bolts to 110 to 120 lbf-ft. (149 to 162 Nm). Tighten 3/8 inch bolts to 34 to 38 lbf-ft. (46 to 51 Nm).
